Manhole Inspection Summary

Manhole # S35Y1_004MH

Insp Date: **11/16/07 1:48 PM**

Location Address: **3914 S. Hanover St.**

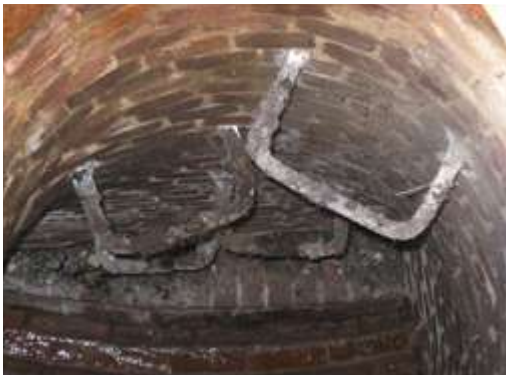
Steps Count: **4** Missing: **0** ☐ Corroded

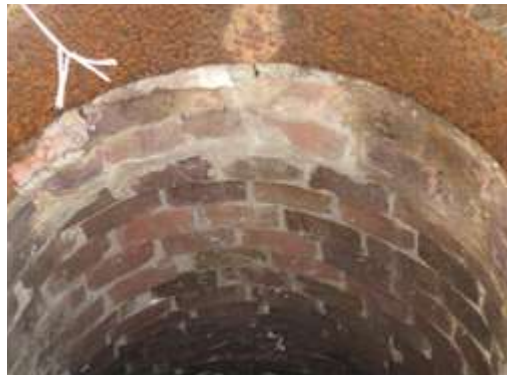
Defect 2

Wall

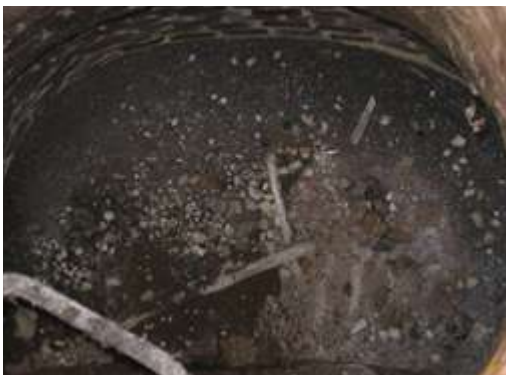
Defect 1

Condition: ☐ Sound ☐ Cracked ☐ Root Intrusion ☐ Deteriorated ☐ Leaks ☒ **Debris**

Debris on bench

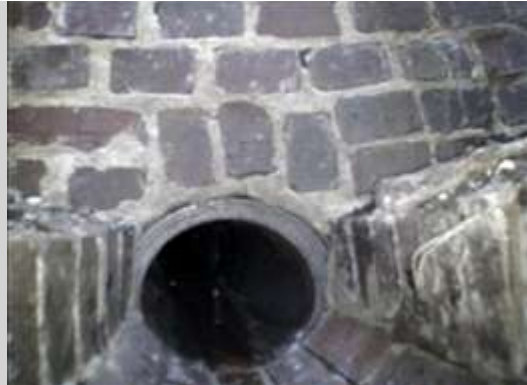
12 O'Clock Outflow

8 in. Circular Gravity Sewer
Pipe Out @ 12 O'Clock

Pipe Height: **8.4** (in.) Rod and Bar (Angled)
Pipe Material: **Clay** ☐ Pipe Lined
Invert Depth: **8.74** (ft.) Flow Characteristics: **Fast**
Deposits: ☒ None ☐ Mud ☐ Sludge ☐ Debris ☐ Grease
Silt Depth: (in.) Deposits Extent:
Infiltration: **None** Pipe Seal Cond: **Sound**

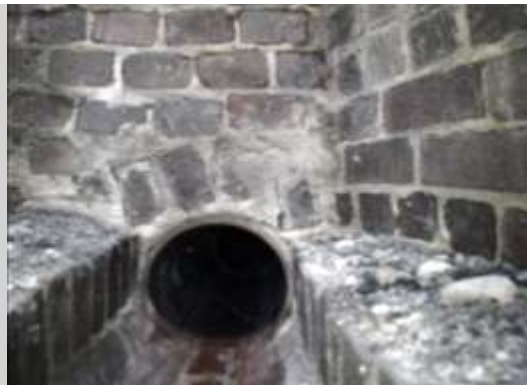
6 O'Clock Inflow

8 in. Circular Gravity Sewer
Pipe In @ 6 O'Clock

Pipe Height: **8.4** (in.) Rod and Bar (Angled)
Pipe Material: **Clay** ☐ Pipe Lined
Invert Depth: **8.38** (ft.) Flow Characteristics: **Fast**
Deposits: ☒ None ☐ Mud ☐ Sludge ☐ Debris ☐ Grease
Silt Depth: (in.) Deposits Extent:
Infiltration: **None** Pipe Seal Cond: **Sound**
